NORRIS COTTON
FEDERAL BUILDING

NBS BUILDING SCIENCE SERIES 133

Performance of the Norris Cotton Federal Office Building for the First 3 Years of Operation

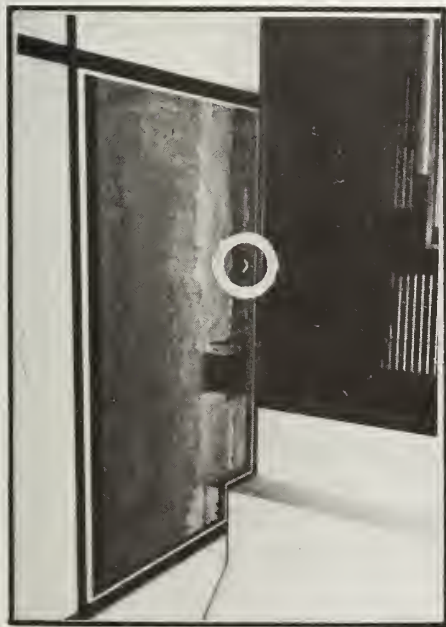
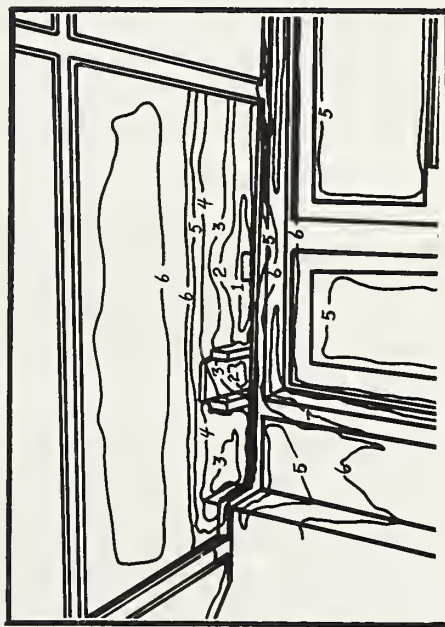
Figure 16. Ceiling with one tile removed on the second floor, west interior wall of the Norris Cotton Federal Office Building

Figure 17. Results of the thermogram on the second floor, west interior wall of the Norris Cotton Federal Office Building (1 = coldest isotherm, 10 = warmest isotherm)

to some extent, the same problems found on the second floor. Even the north wall on the third floor was found to be substantially cool. This was surprising since there are no windows on the north wall and the construction is different than on the other three. Air must have been infiltrating the cavity space here along some path different than that on the other three walls.

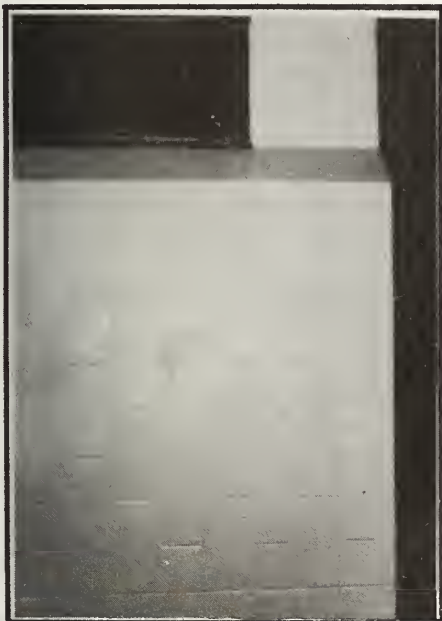
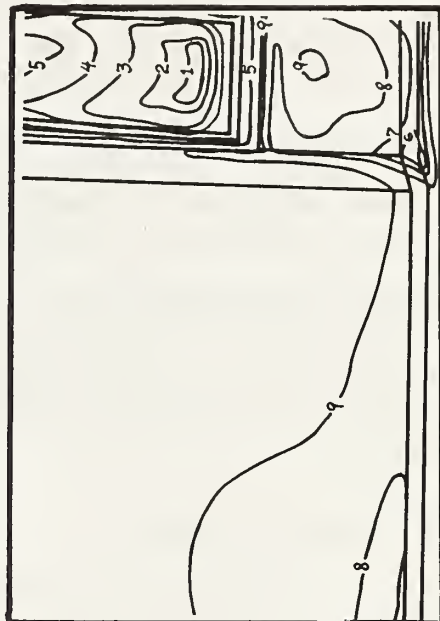
Figure 18. Properly insulated wall, sixth floor, east interior wall of the Norris Cotton Federal Office Building

Figure 19. Results of the thermogram on the sixth floor, east interior wall of the Norris Cotton Federal Office Building (1 = coldest isotherm, 10 = warmest isotherm)

There were some areas that were free of this air leakage problem. Figures 18 and 19 for example, were taken along the east wall of the sixth floor and the results were indicative of what should have existed throughout the building; a much warmer wall and floor surface than window surface.
